## Don't Blow that Tranny! Part 2 (unedited version)

by DAVID JUNG

Last month, we dropped off a toasted output transformer from a 1950 *Vox AC15* with Sergio Hamernik and the team at **Mercury Magnetics**. From a suspicious pin-sized burn in the transformer's outer paper insulation, they were able to determine probable causes for the transformers untimely demise. Then it was onto the rewind process! So, is it over for this amp's output transformer?

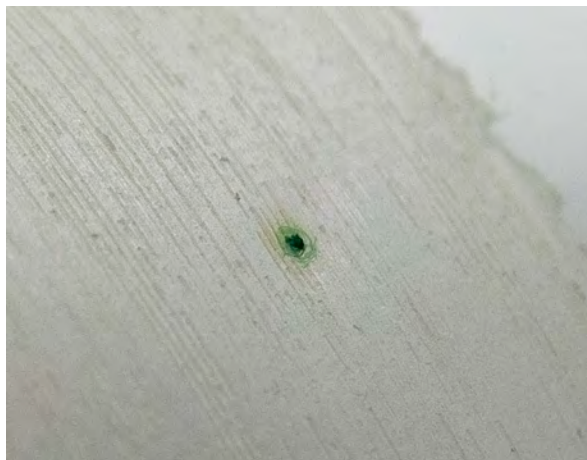
An extreme close-up of the burn mark at the first layer of insulation. Notice where the ionized copper left a green-colored mark.

killed by a sharp instrument that penetrated the outer insulation that broke through and severed two turns of the fine wire that make up 1/2 of your primary winding. Meaning that only one of the two power tubes was operational. The damage to the entire transformer was limited to that spot and only the very top layer of the magnet wire. Those broken wires were arcing across each other and taking advantage of the oxygen available from the perforation of the outer wrap to form that black spot. Further evidence to support these findings is the fact that the rest of the winding, all the way down to the bobbin, was unharmed.

This type of injury is caused by the usual suspects – the installer or remover of the transformer. The smoking gun possibilities are: the tip of a soldering iron, the tip of a Phillips screw driver... or rough handling (dropping or bumping the transformer against something sharp, etc.) with enough force to puncture it to cause such a failure. And finally, we cannot rule out beer as another possibility.

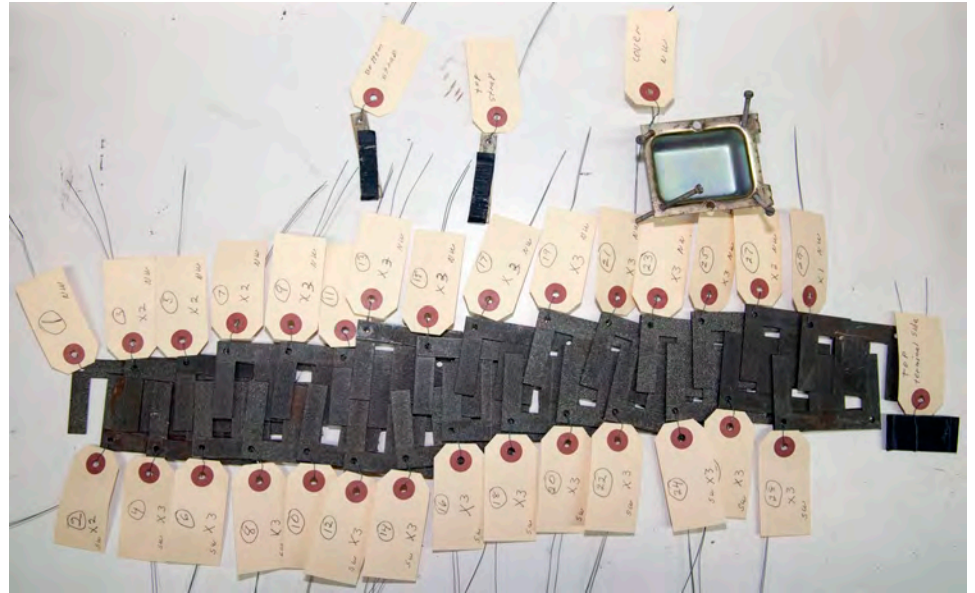
The AC15's transformer after it was fully disassembled.

it. So the first thing we do is remove the core stack and catalog each plate for original position and sequence. Check out the photo of your core completely apart and tagged. We did find some rust and will do our best to preserve it.

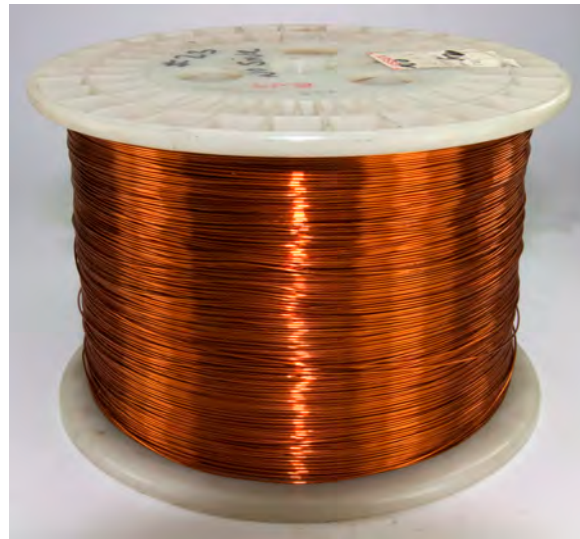
A sample of wire we're going to use for the restoration.

That brings up a couple of interesting and important points. First, Mercury is probably the only company in this industry that uses high-purity OFC (oxygen free copper) magnet wire made in here the U.S.A. – which we use exclusively because of its guitar tone (as well as our hi-fi audio) properties. This type of wire is clearly sonically superior and more consistent than the wire that was used in the '50s and '60s. Wire technology back then was limited to about half of the temperature and electrical performance of Mercury's standards. As a result, transformers using our materials last longer, take

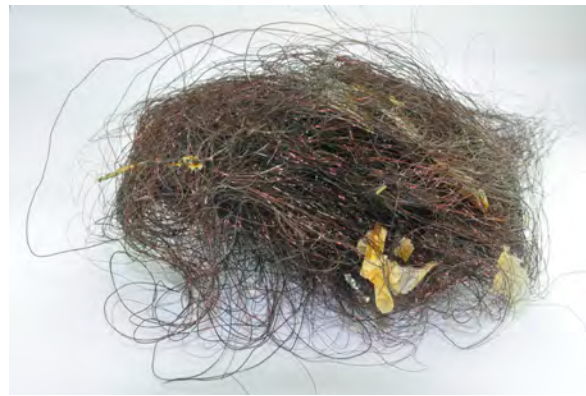
This is what your wire looks like when it's unwound from the transformer.

Magnet wire is not bare copper wire. There is a micro thin coating of plastic insulation that protects it from shorting. That very thin layer of plastic is susceptible to microscopic spider web-like cracking. And the process of unwinding the magnet wire virtually assures it's going to get damaged.

Check out the photo of what the magnet wire from your transformer looks like after it was unwound. Does this look like something you'd want to put back in your transformer?
